Fire Engineering®

Construction Concerns: Concealed Comustibles Article and photos by Gregory Havel

October 31, 2012

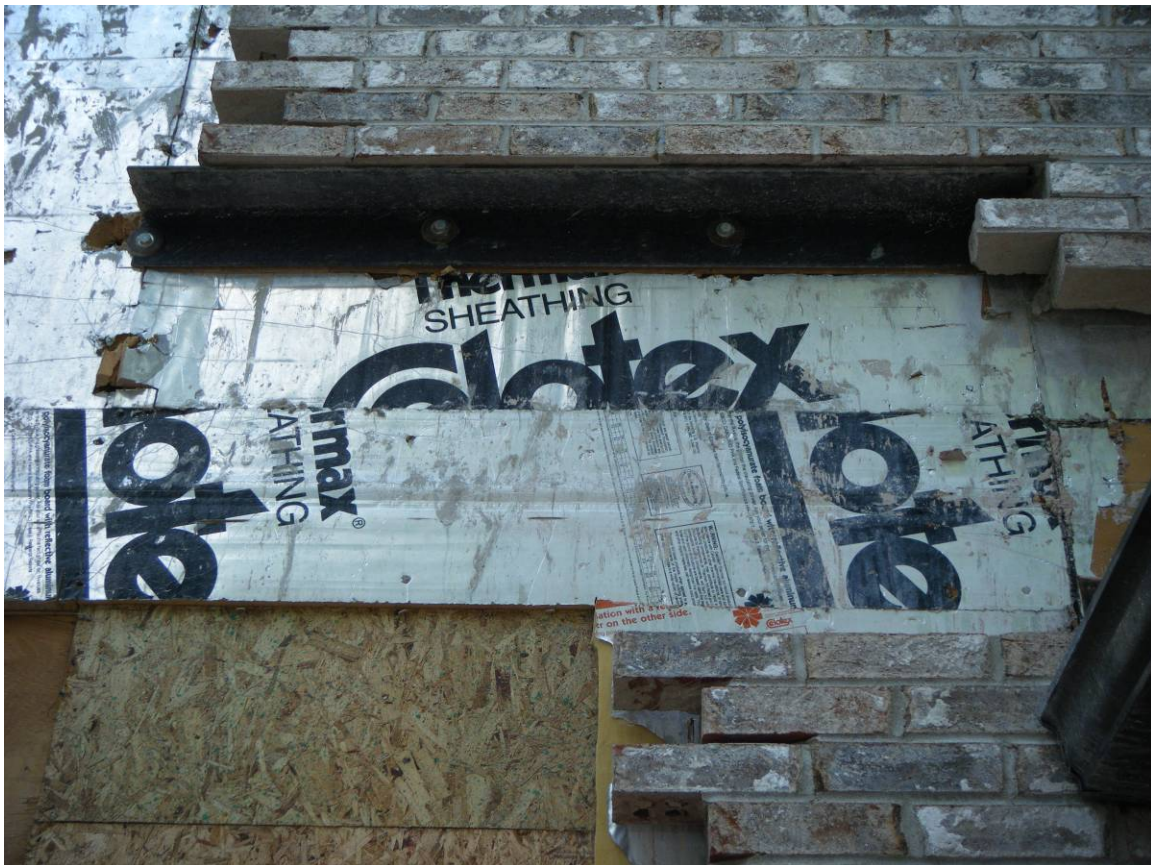
Photo 1 shows a small commercial building that is being remodeled. The exterior was brick, and will remain brick, with a new main entrance. Removal of some of the exterior

brick shows that this is not a masonry load-bearing wall, but a wood-frame load-bearing wall with brick veneer. Since this structure was built in the early 1980s, the studs are 2x4 and the sheathing is polyisocyanurate insulating foam board with foil facing. This foam board is combustible, although it should extinguish itself if its ignition source is removed.

The weight of the masonry above the new entrance will not be supported by the cultured stone lintel that will be installed to cover the foil-faced foam board sheathing. It will be supported by the steel angle that has been lag-screwed through the sheathing into the 2x4 studs. This building appears to have exterior walls of brick masonry. However, all of the loads are carried by combustible wood framing, including the eccentric load of the brick veneer above the doors and windows. The inside of the studs will be finished with gypsum drywall board.

If we assume that this is a “solid brick wall” from its outward appearance, we will be surprised when we are buried under an avalanche of loose brick released by the burning away of the structural supports.

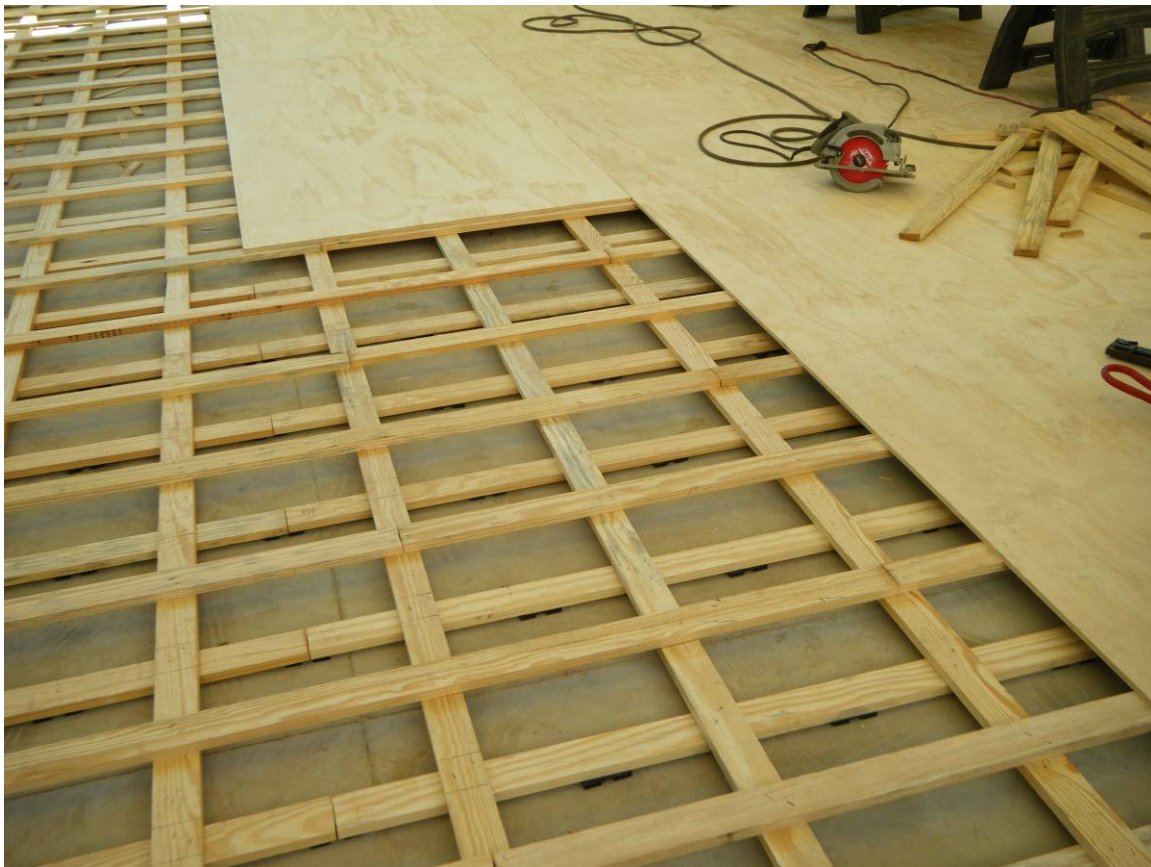
Photo 2 shows the partially-completed floor in a dance studio attached to a large school auditorium. This building is of non-combustible construction, with masonry load-bearing walls and steel bar-joists supporting a gravel-ballasted insulated membrane roof on a steel roof deck. This building has a complete fire sprinkler system according to National Fire Protection Association Standard 13, *Installation of Sprinkler Systems*, 2010 edition—except for the combustible space concealed under the dance floor. The dance floor will be seamless vinyl applied to the top of the plywood subfloor; which is supported

on three layers of widely-spaced one-inch (25.4 mm) hardwood boards laid at right angles to each other; which are supported by a concrete slab-on-grade.

This type of resilient floor construction is common in gymnasiums, dance studios, and other facilities designed for intense athletic activities. It is used to reduce the possibility of foot, ankle, and knee injuries.

If we become complacent because of the noncombustible structure and the presence of a sprinkler system, we will be surprised when we discover that the space under the floor has provided a channel for fire and smoke travel; or that the fire's origin was between the finished floor and the concrete subfloor. When our feet, knees, or hands break through and are trapped by a floor of this type, it is too late to remember that we should have used our thermal imaging camera or a sounding tool to locate the hot and weak spots before moving in.
