Five Fall in Hackensack

An early report of the tragic fire at a New Jersey auto dealership gives up some critical lessons about bowstring truss failure and rescue operations at large-scale collapse sites.

BY GLENN P. CORBETT

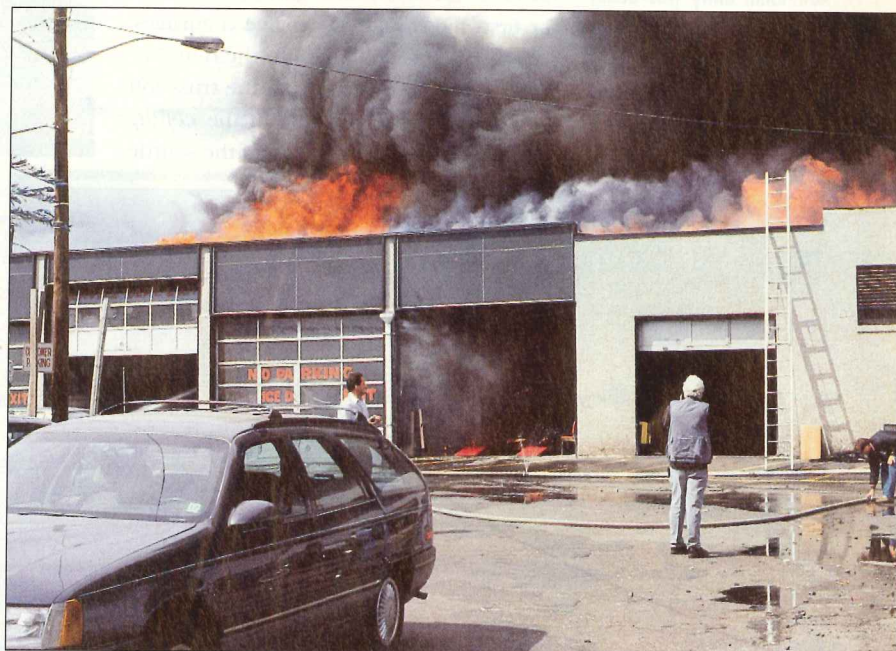
Fire in the truss loft above the service bay area (above) extends through the roof and flashes over roofing material moments before collapse of the bowstring truss assemblies (photo at left), trapping firefighters. Photos by Arthur Knobloch.

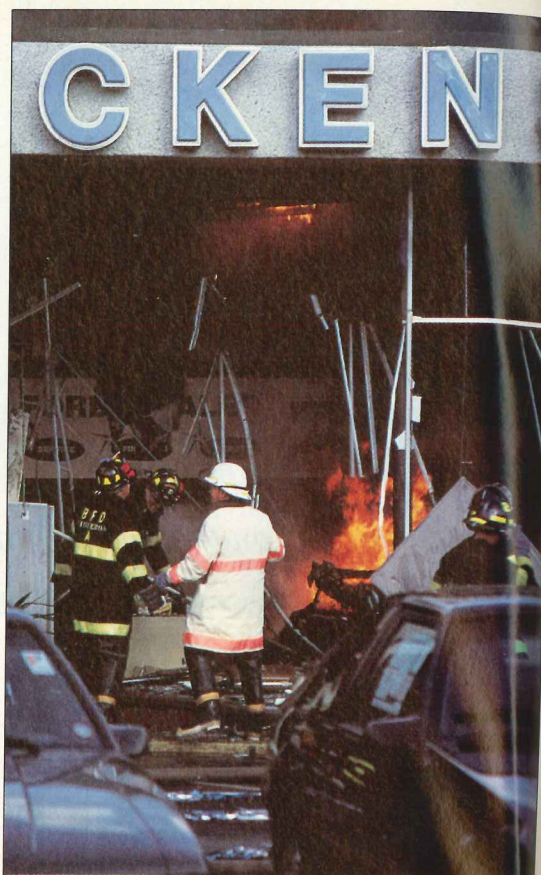
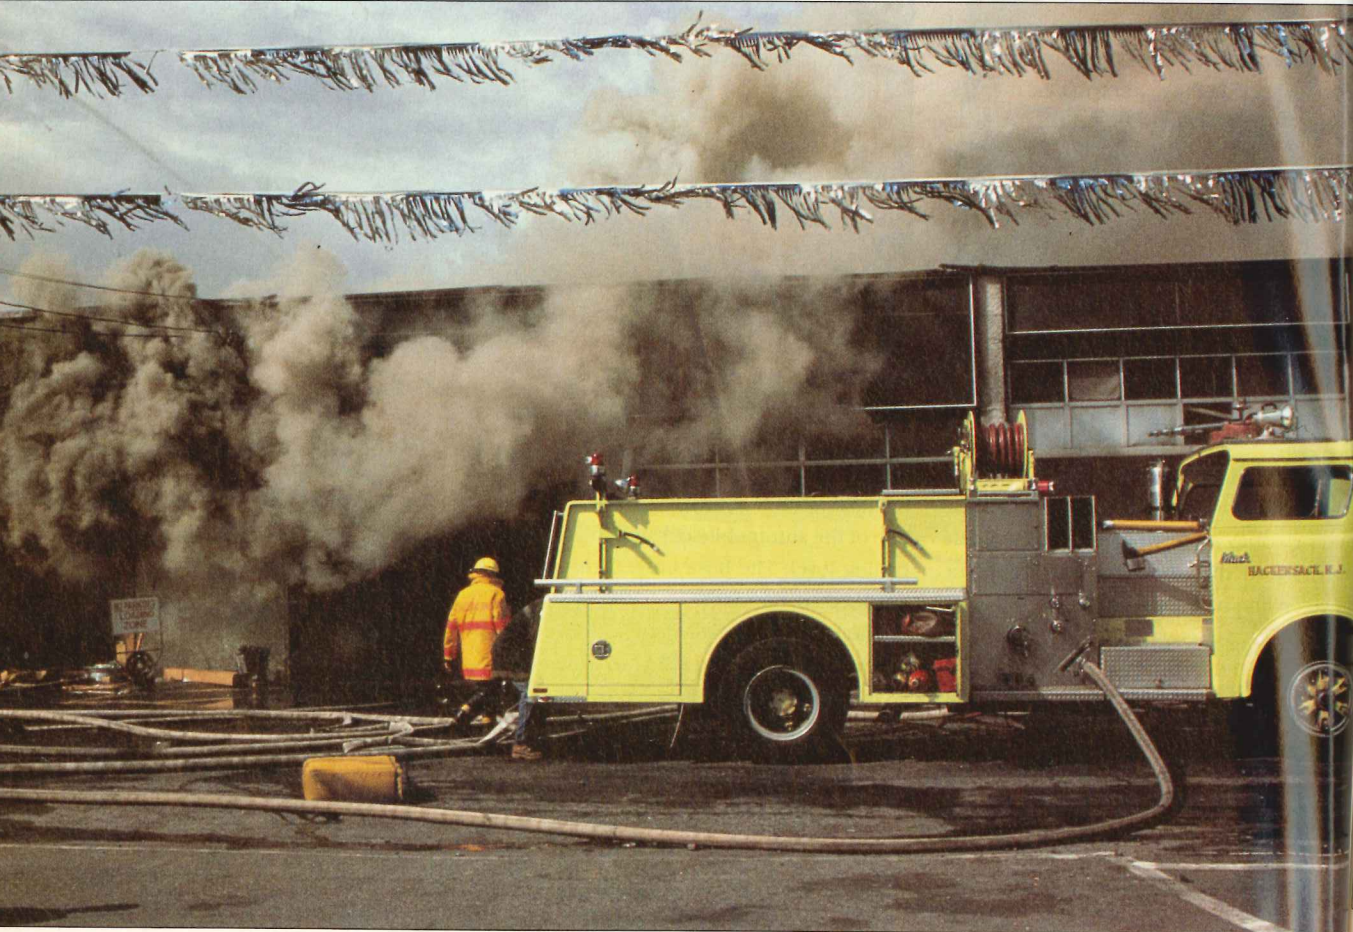
After collapse, rescue efforts were mounted from exposure 1 (photo at right) and exposure 4 (below).

Additional entry was being attempted from the rear (exposure 3) by breaking the enclosure wall. Photos by Ronald Jeffers. Next page: layout of the Hackensack Ford dealership.

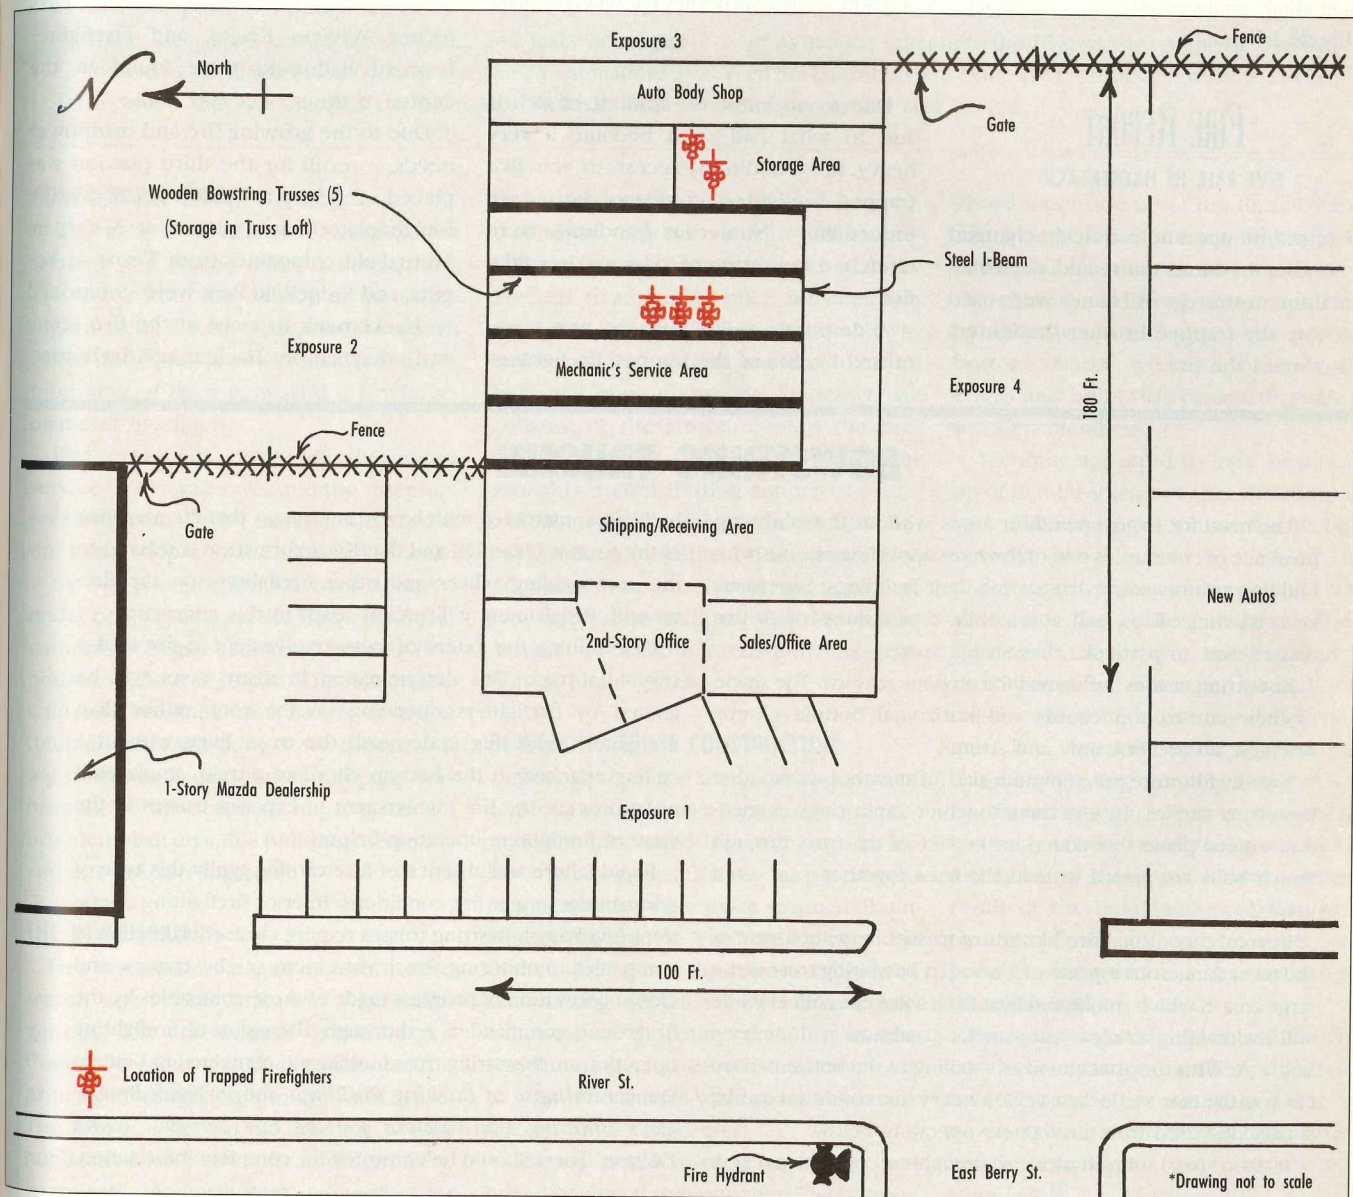
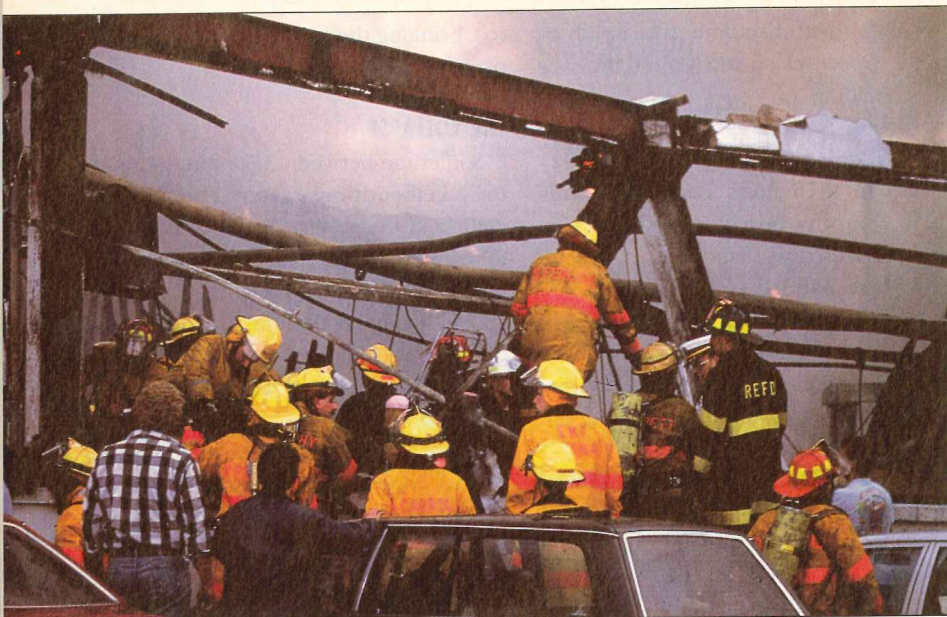
Rescue efforts continued until the last firefighter fatality was located hours after the collapse. Photo by Ronald Jeffers.
