Fire Engineering®

Construction Concerns: Electrical Needs

Article and photos by Gregory Havel

October 6, 2014

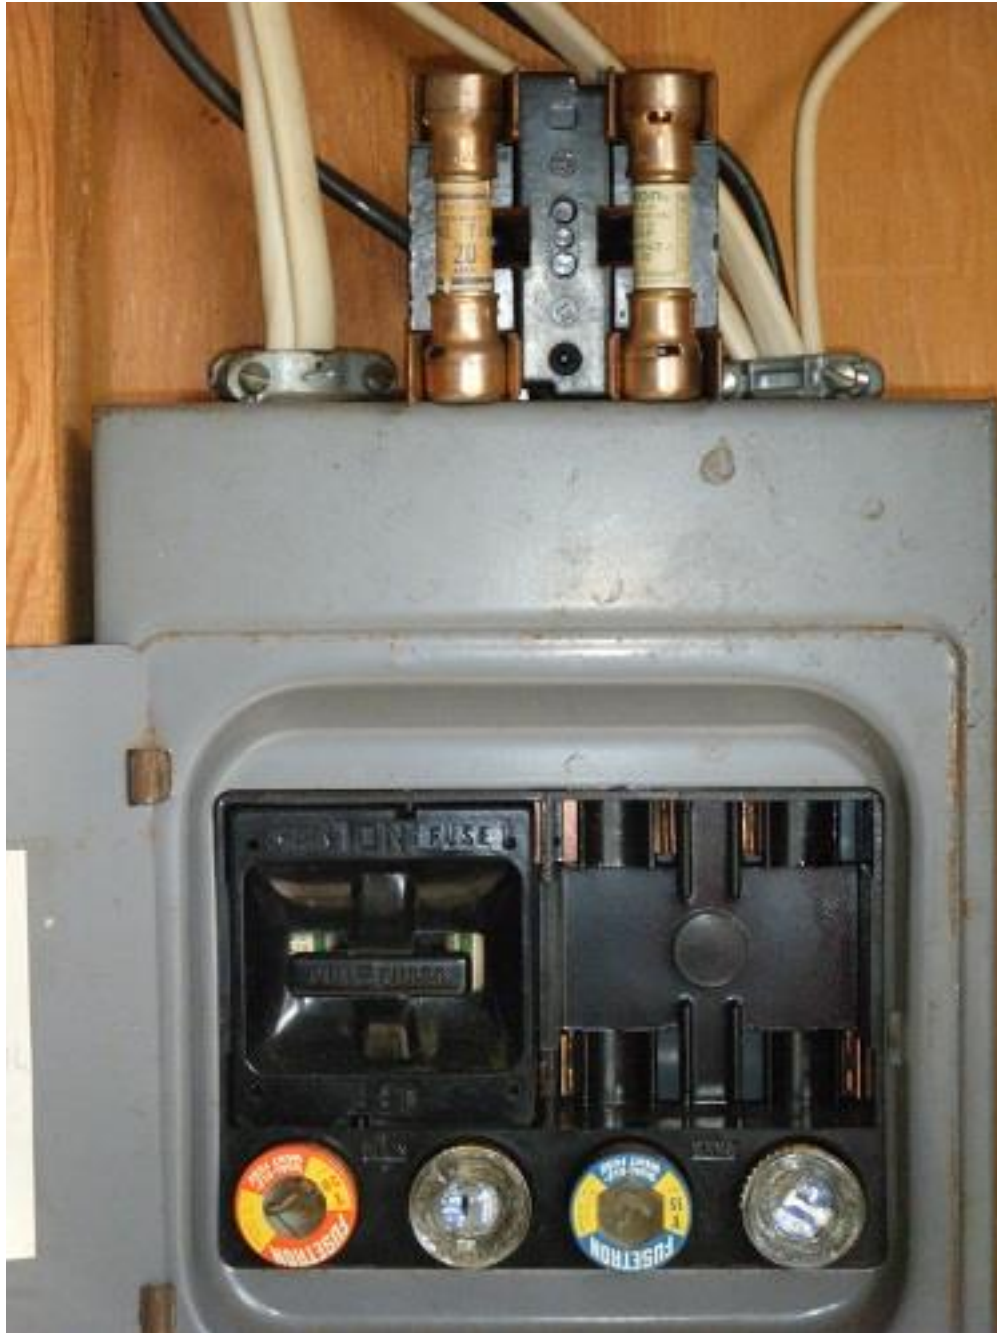
(2)

When these fuse blocks were pulled out, the cartridge fuses were exposed on their back sides, as shown in Photo 2. If there was no electric range, this fuse block could be used to provide power to another fuse box elsewhere in the house, or to a garage or other outbuilding. When a fuse block was inserted so that the word "ON" was right side up at the top, the copper blades on the fuse holders made contact inside the panel, and energized the fuses and wiring in the lower part of the panel. When the fuse block was inverted and inserted so that the word "OFF" was right side up at the top, the fuse block could be inserted, but no contact was made.
