# Fire Engineering®

## Construction Concerns: Impalement Hazards

*February 29, 2016*

*By Gregory Havel*

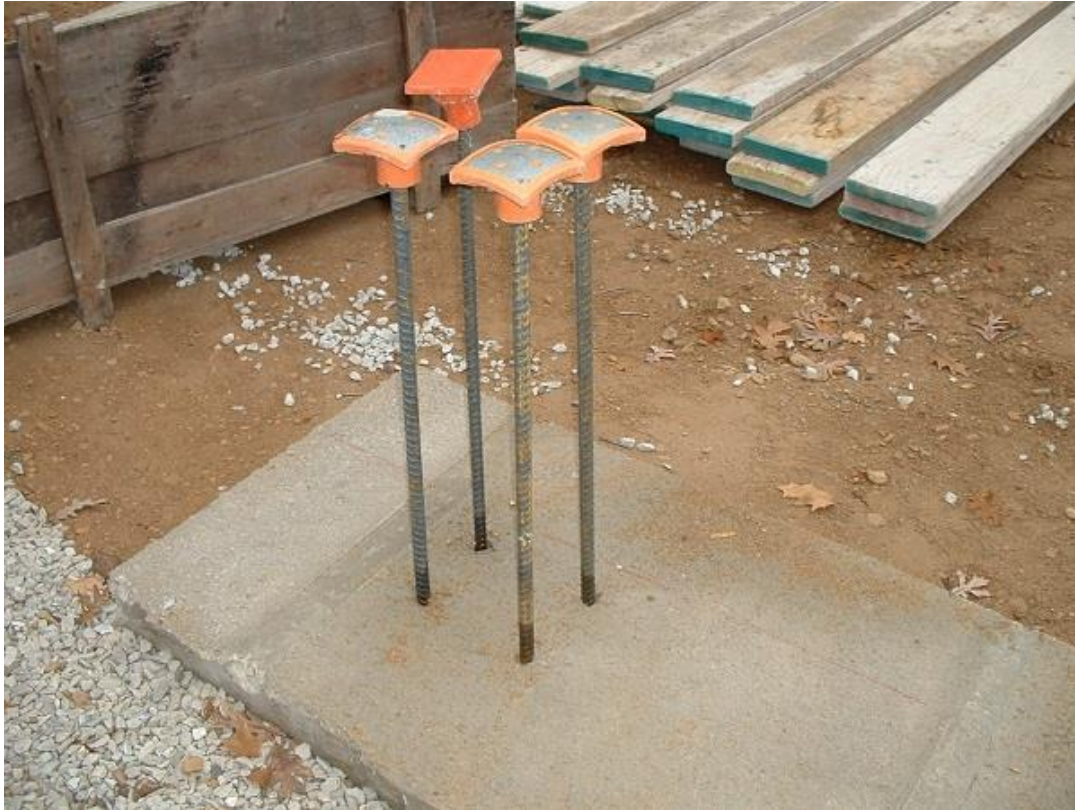
(1)

Impalement hazards can be especially dangerous because of poor visibility. The most common impalement hazard is the steel bar (rebar) that is used to reinforce concrete. The Occupational Safety and Health Administration (OSHA) in 29 CFR 1926.701(b) requires that the exposed ends be covered with a metal-reinforced cap (photo 1), lumber at least 1½ inches thick, or other protection for workers against injury by cuts or by impalement from falls. In poor lighting or dusty conditions or in the glare of bright sunlight, rebar can blend into the background of concrete and concrete block.

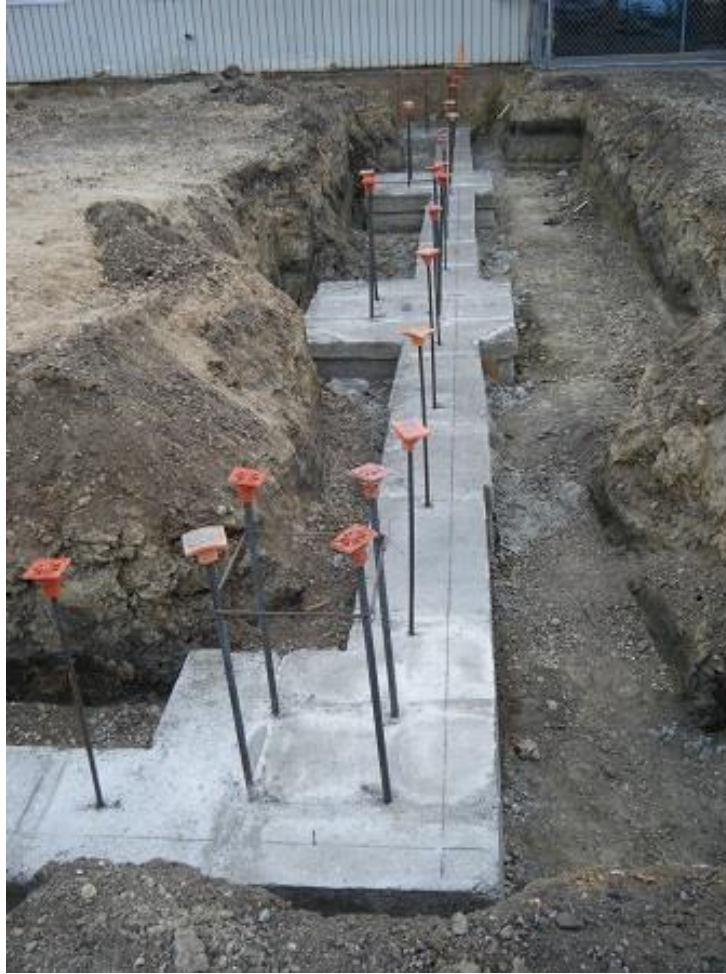
(2)

Rebar is installed vertically in footings (photo 2) to reinforce the foundation walls that will be built on them. These rebar often extend upward from the footings through the cores of the concrete block wall to the bearing plates for beams, girders, or joists at the top of the wall. At any time that workers could be exposed to the hazard of cuts or impalement on rebar, the ends are supposed to be capped (as they are in the photos) or otherwise protected.

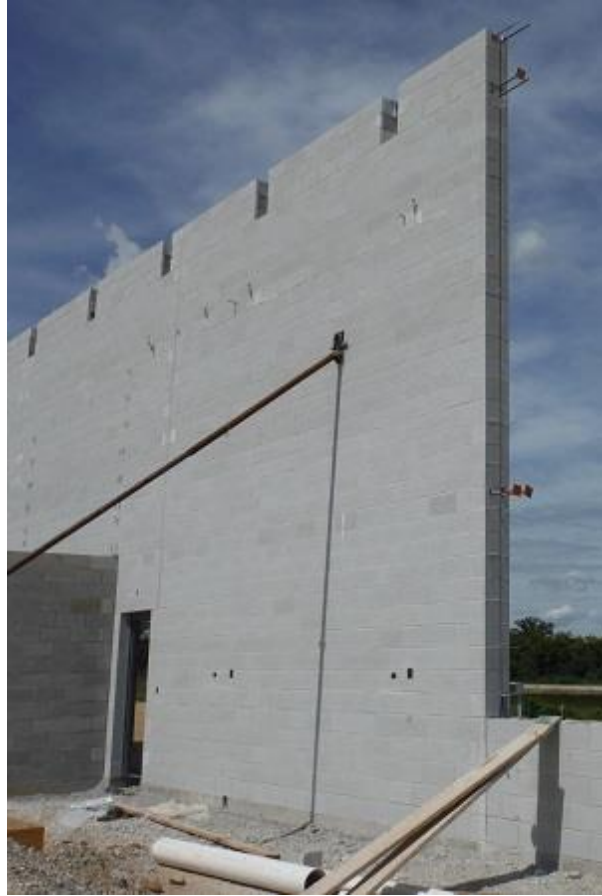
(3)

Rebar is also installed horizontally in footings, in foundations, in poured concrete walls, and in “bond beams” (photo 3) in concrete block walls. If rebar ends are properly protected, tripping and landing on them will not cause impalement, but it can still leave a nasty bruise. In photo 3, the rebar in the lower bond beam is capped properly. In the upper bond beam, the rebar will have to be capped before additional work begins in that area.

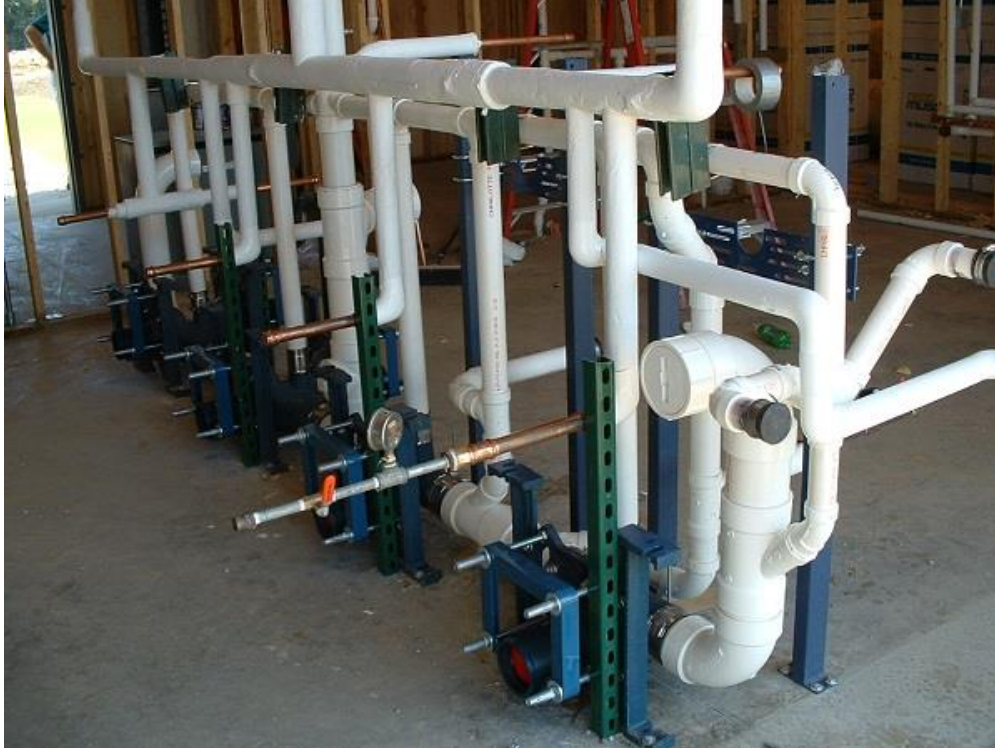
(4)

Although rebar is the most common impalement hazard at a construction site, it is not the only one. Others include any kind of stored material or equipment and pipes stubbed out of completed walls in unexpected places. Photo 4 shows the water supply and waste pipes for the plumbing in a school washroom. Although only the most rigid of these pipes and mounting bolts could cause impalement, the rest can still cause bruises, abrasions, and other injuries if someone falls against them.
