## Construction Concerns: Improvised Scaffolds

March 20, 2017

By Gregory Havel

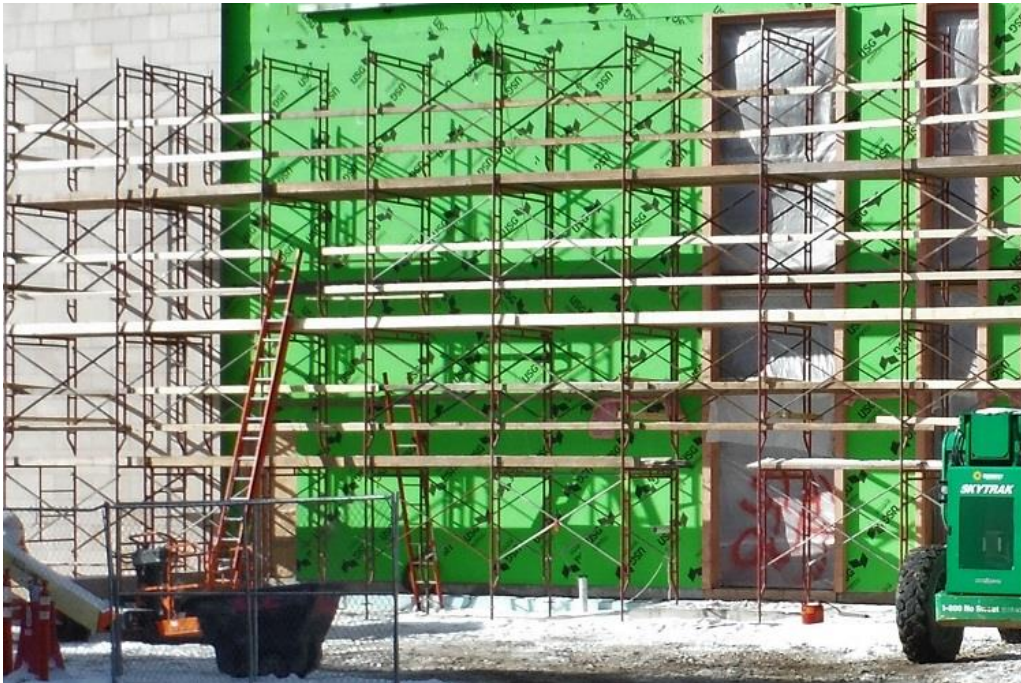
(1)

Photo 1 shows a scaffold that has been constructed to the scaffold manufacturer’s and OSHA’s requirements.

Although this scaffold is not yet complete, it has been adjusted to plumb and leveled by screw jacks on wood mudsills on compacted soil. Each deck level is fully planked. Each deck level has a guardrail with top-rail, mid-rail, and toe-board. Before it is released for use to the insulators and bricklayers, the scaffold will be tied to the wall behind it; extended to its full height; and inspected again for plumb and level, missing components, and any other defects and hazards.

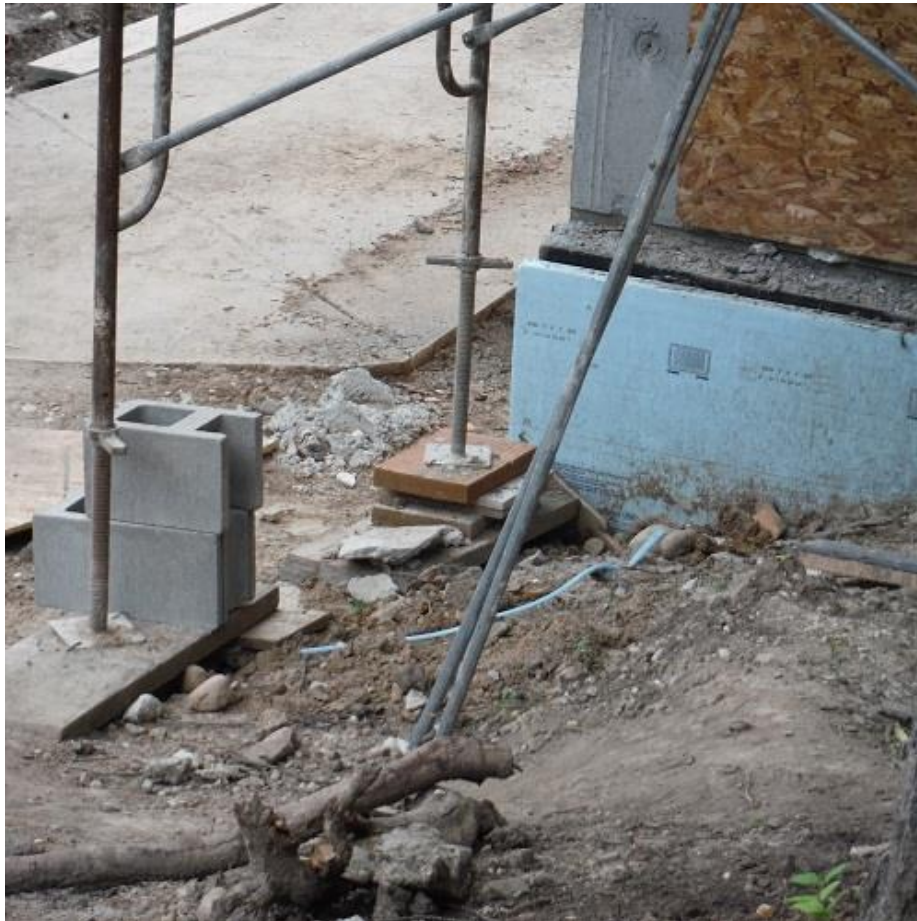
(2)

Photo 2 shows the foundation for a scaffold's pair of legs. The mud pads are set on uneven ground and have voids beneath them.

The screw jacks are at maximum extension, and one has been supplemented by stacked pieces of scrap lumber. This is a hazardous and unstable condition; the mud pads can collapse into the voids beneath, and the stacked pieces of lumber can shift beneath the scaffold leg. This area should have been leveled before the scaffold was set and the ground level adjusted so that the stacked lumber and screw jacks being at maximum extension would have been unnecessary.

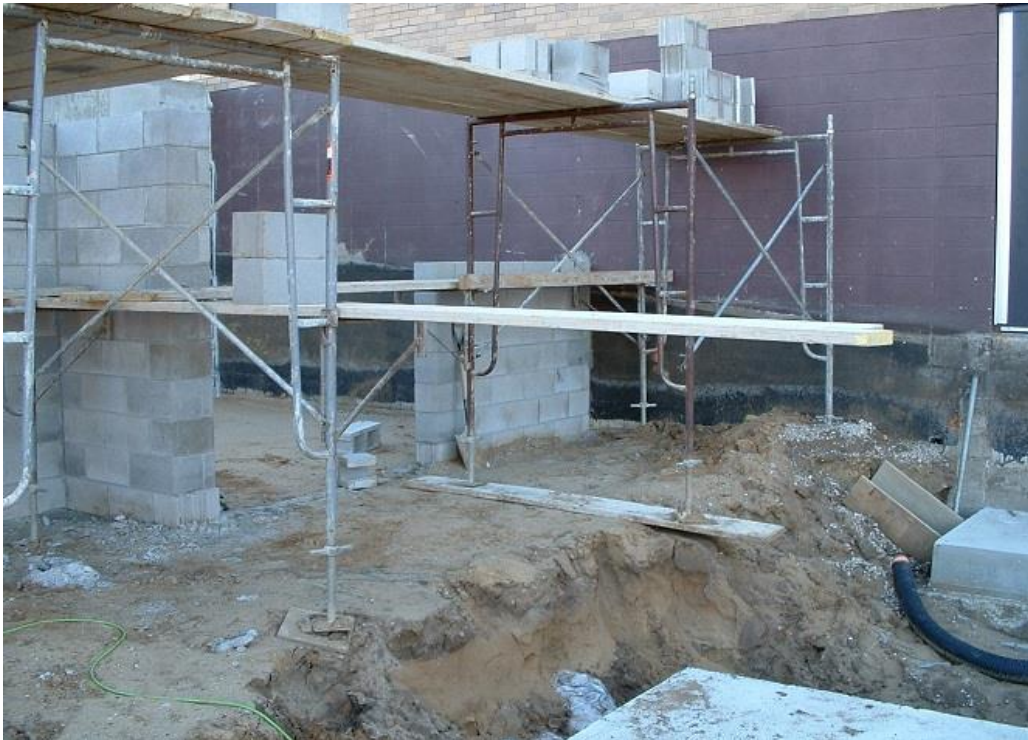
(3)

Photo 3 shows a scaffold that was set before the ground was ready. The scaffold has been set on the edge of an excavation, which could cave in under the weight of the scaffold, building materials, and workers.

The scaffold leg in the foreground is set on a mud pad that is already slipping into the excavation, making the scaffold unstable. The scaffold leg beyond it is set on a mud sill that is cantilevered over the edge of the excavation, and that depends on the other leg on the mud sill as a counterweight. This scaffold should not have been set until the excavation was backfilled and leveled with compacted soil.

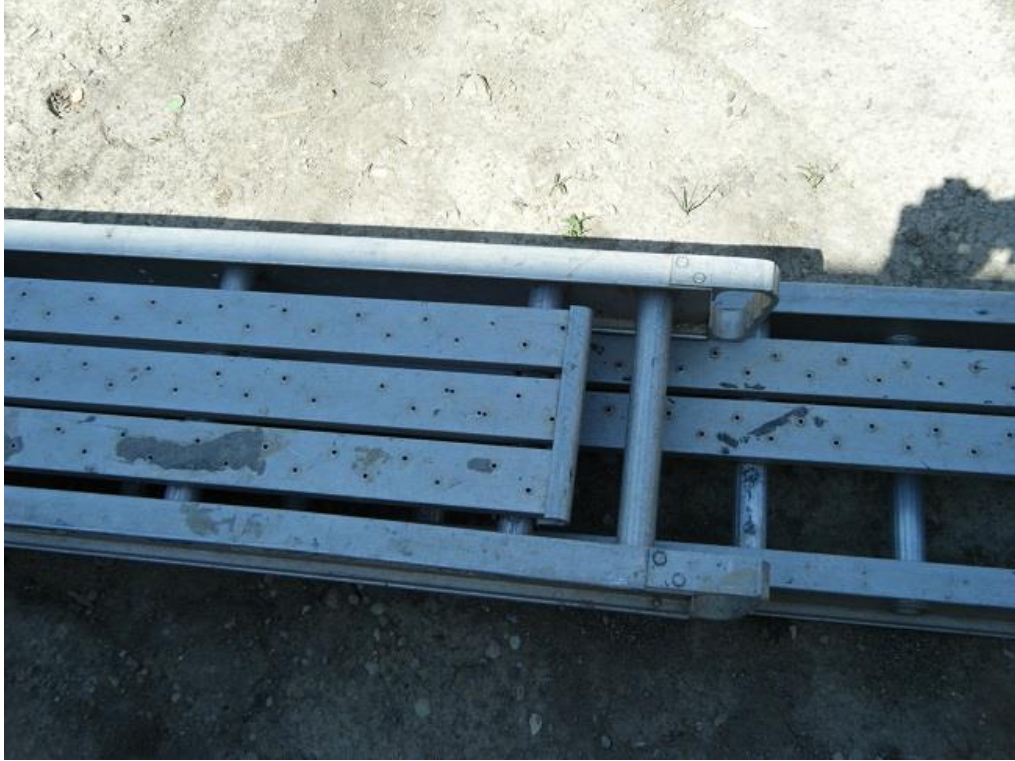
(4)

A second common defect is the use of defective components. Photo 4 shows two aluminum planks that were in use as part of a “ladder-jack” scaffold [OSHA’s 29 CFR 1926.452 (k)]. The plank on the left is intact. The plank on the right is missing one-third of its walking and working surface, has less strength than its design, and provides a trip hazard for anyone working from it.

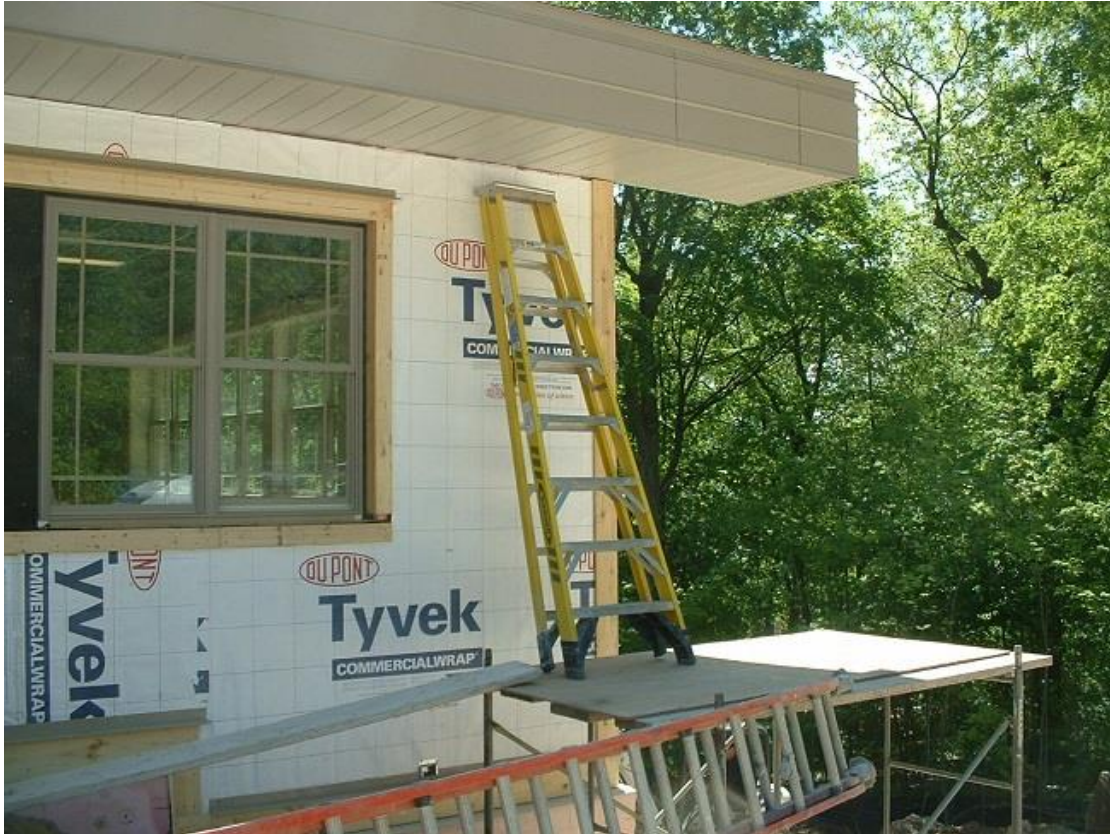
(5)

A third common defect is the use of ladders to supplement the height of a scaffold. Photo 5 shows a stepladder in use on top of a scaffold. The scaffold itself is missing its guardrail and has only a single plank connecting it to the adjacent parts of the scaffold (rather than a full plank deck). In addition, the stepladder was in use leaning against the wall, a position for which it was not designed; the stepladder in this position forces the scaffold away from the building and can lead to a fall and serious injury by the worker as well as the collapse of the scaffold.

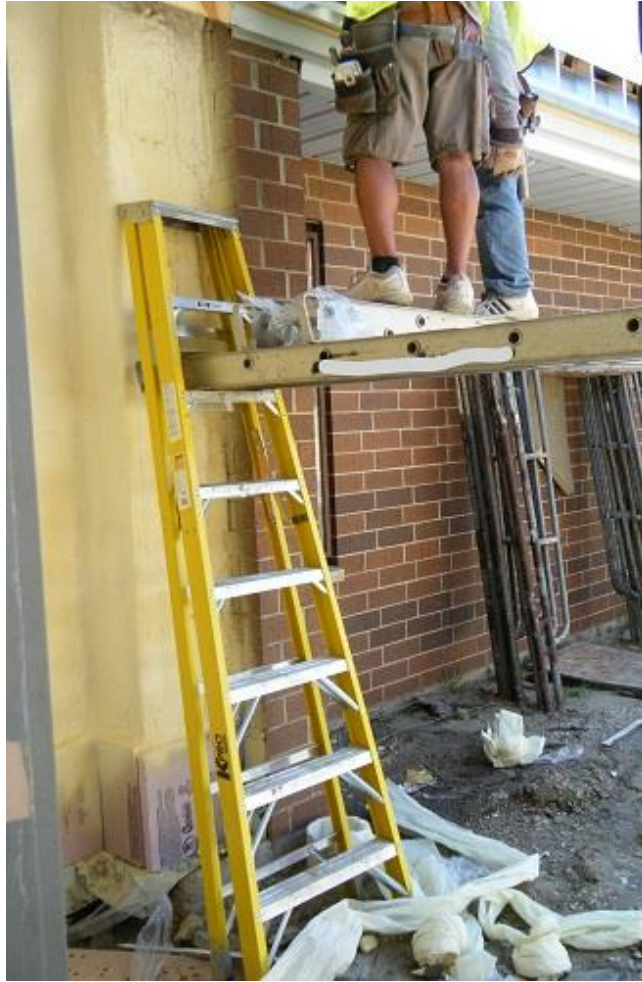
(6)

A fourth common defect is the use of improvised equipment and materials to make a scaffold. Photo 6 shows a scaffold built of aluminum plank supported by stepladders leaning against the wall.

According to the scaffold standards, a scaffold walkway must be at least two planks wide and be supported by either scaffold frames or a job-built scaffold that has been designed according to OSHA's scaffold standard and its appendices. These standards do not permit the following:

- The use of a single plank supported by a stepladder.
- The use of a scaffold supported by a stepladder.
- The bridging of one plank to another on a ladder-supported scaffold.

The ladder standards do not permit a stepladder to be used other than in an open position with its spreaders locked.
