Fire Engineering®

Construction Concerns: Thermal Breaks

Article and photos by Gregory Havel

June 25, 2018

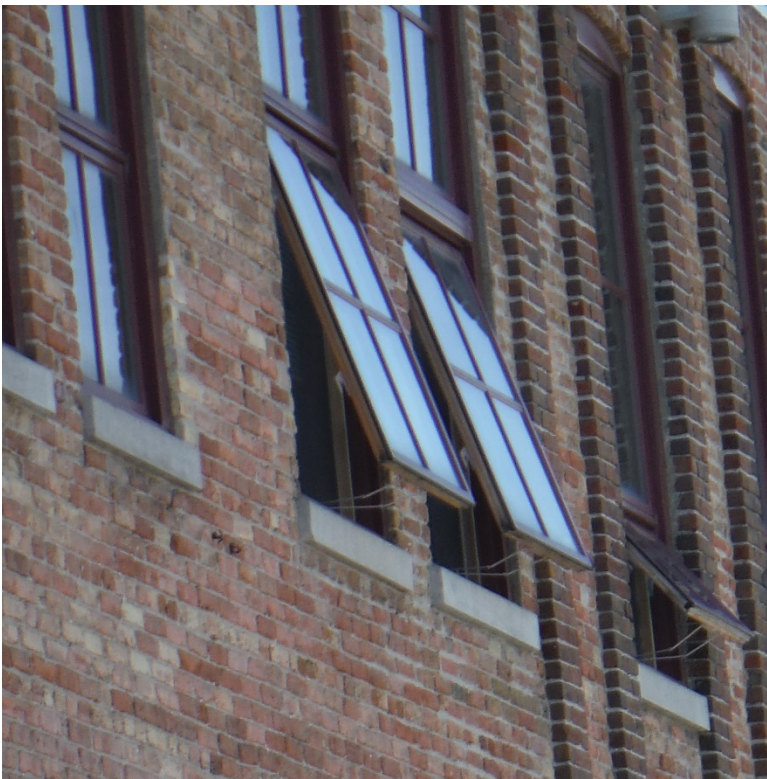
(1)

Before this time, windows of commercial buildings were often a single plate of glass held in a rigid steel or aluminum frame (Photo 1). These windows had little or no insulating value, and heat was transferred easily from inside to outside the building through the single-pane glass and metal frame.

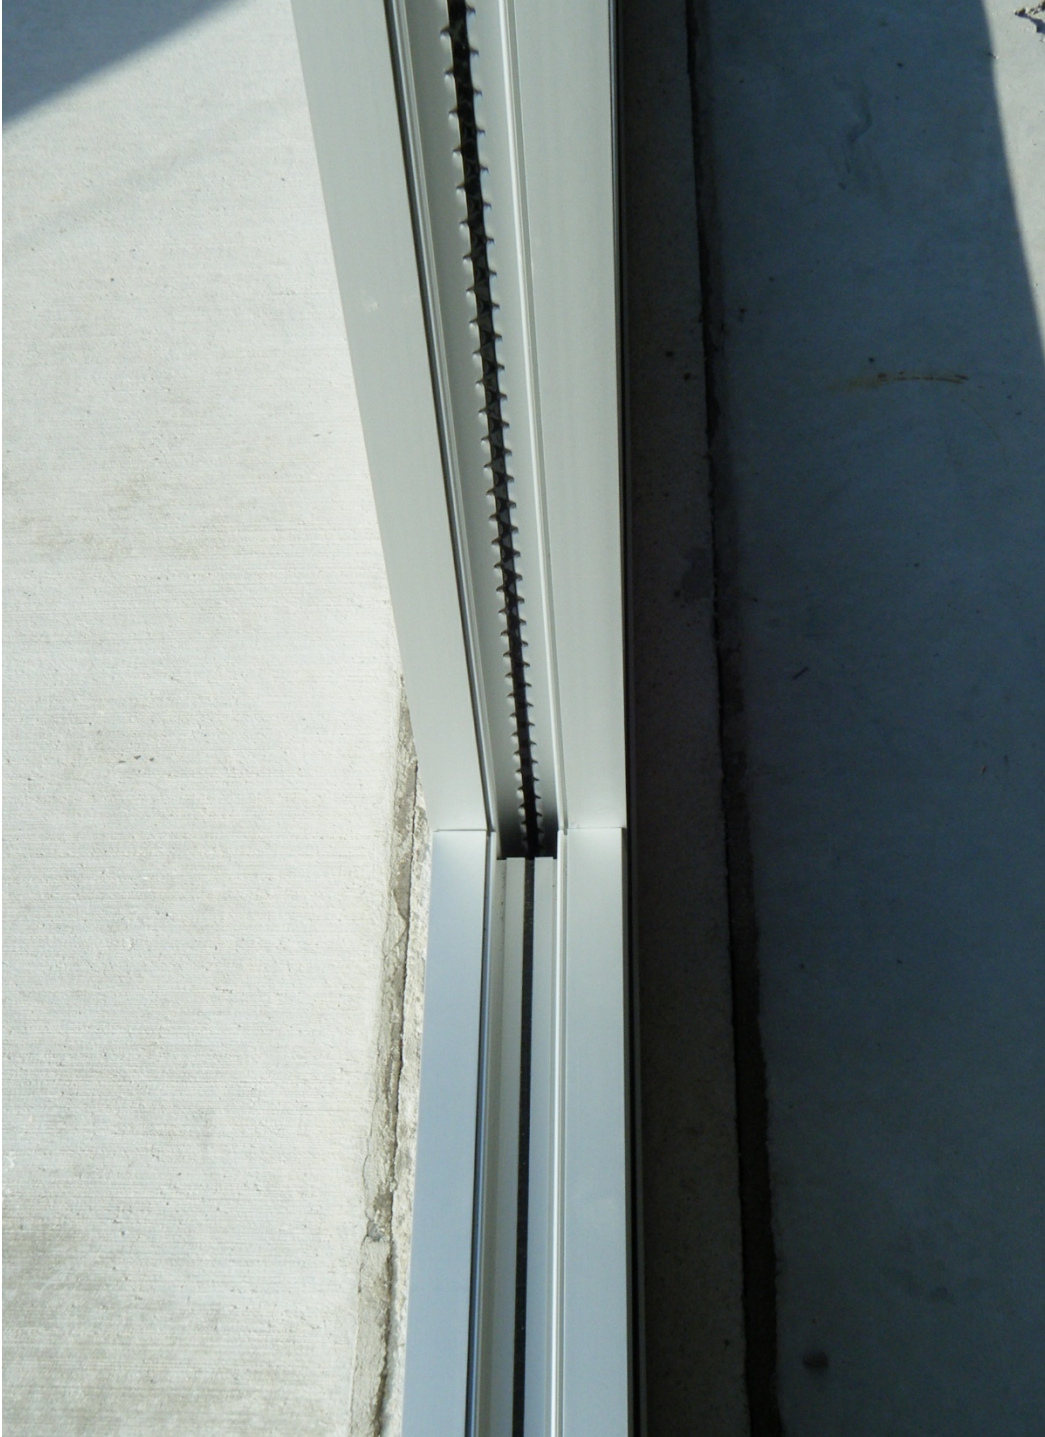
(2)

If the building's owner preferred, insulating glass (Photo 2) could be installed in the metal frame to reduce heat loss. Insulating glass is sold under a variety of brand names. All of these brands are similar in that they use two panes of glass separated by an insulating and sealing strip around the edges. The cavity between the two panes of glass has its

air replaced with one of the inert gases like argon, at less than atmospheric pressure, which transfers heat more slowly than air.

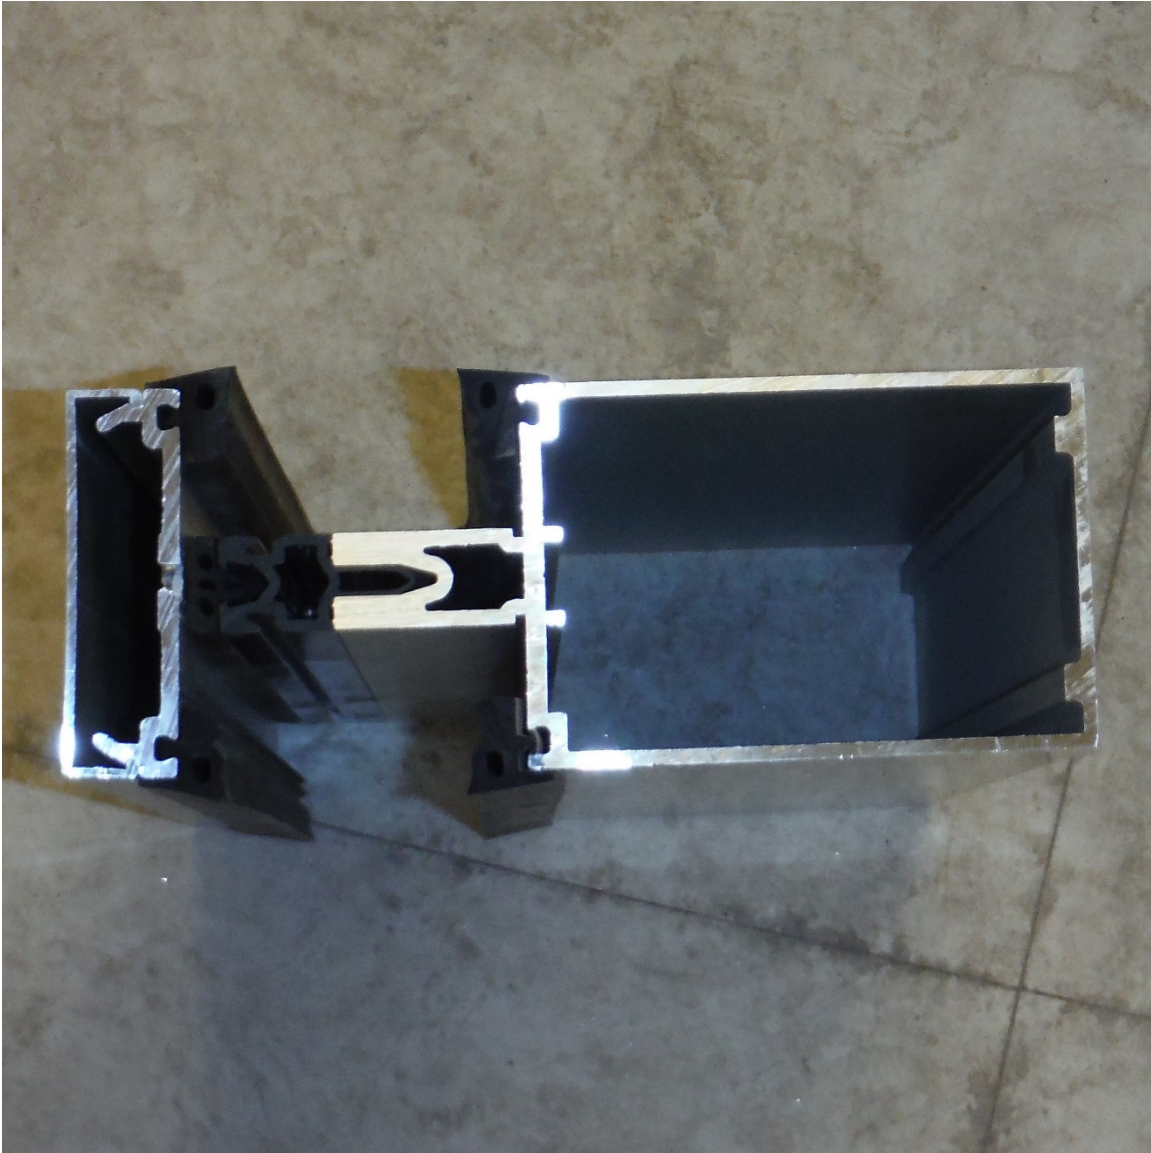
(3)

Photo 3 shows a cross-section of a modern commercial window or store front, viewed from above. At the right (interior) is the main structural support, a rectangular aluminum tube, for this window and frame assembly. At the left (exterior) is the aluminum interior trim that holds the panes of insulating glass in place and seals the joints against the weather with plastic strips that are mounted in channels in the aluminum, and which press against the glass. Between these two aluminum members is a connection made of plastic, known as a “thermal break” or “thermal barrier,” which is a poor conductor of heat when compared to the aluminum. Insulating glass is installed in the channels at the top and bottom of the photo.

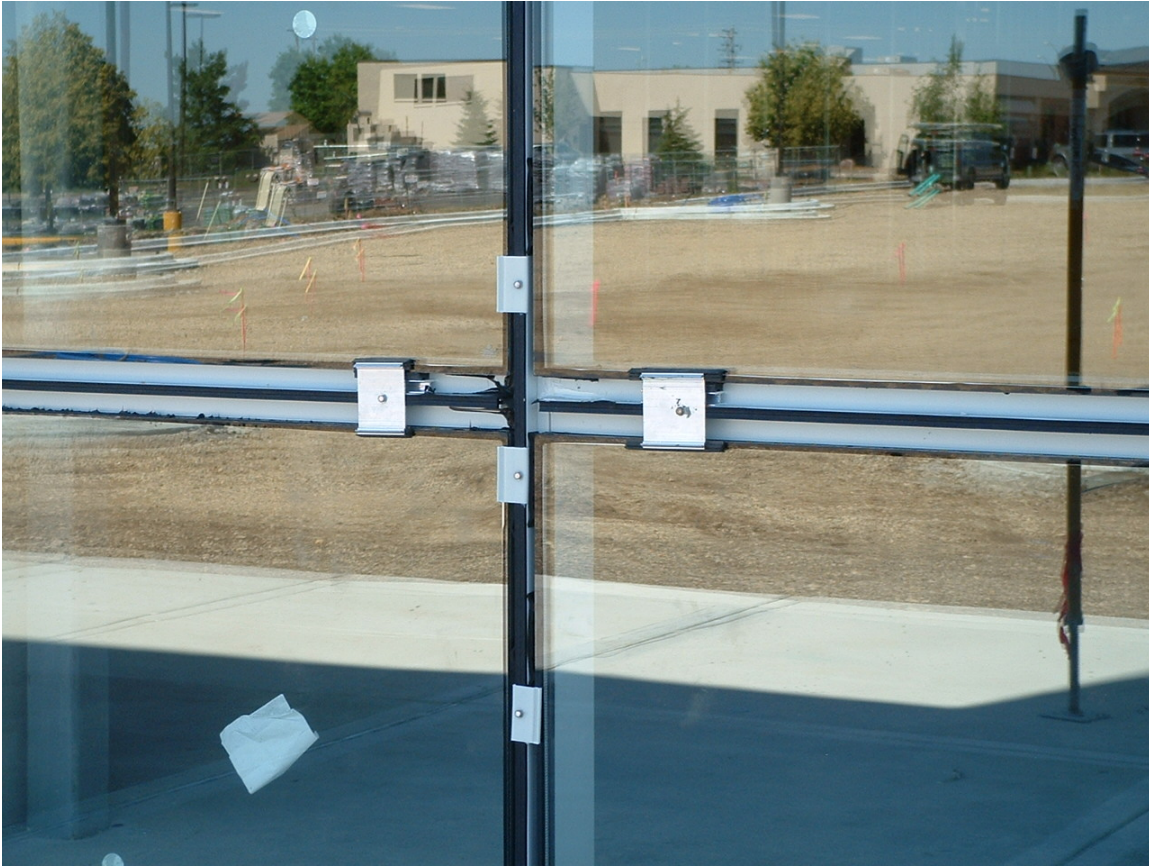
(4)

Photo 4 shows an aluminum store front with the insulating glass installed and held in place by aluminum clips fastened by screws. The aluminum exterior trim with the weather seal will be installed over these clips.
